# CHURCH OF THE HOLY SEPULCHRE JERUSALEM

STRUCTURAL SURVEY  
FINAL REPORT

WILLIAM HARVEY

1935

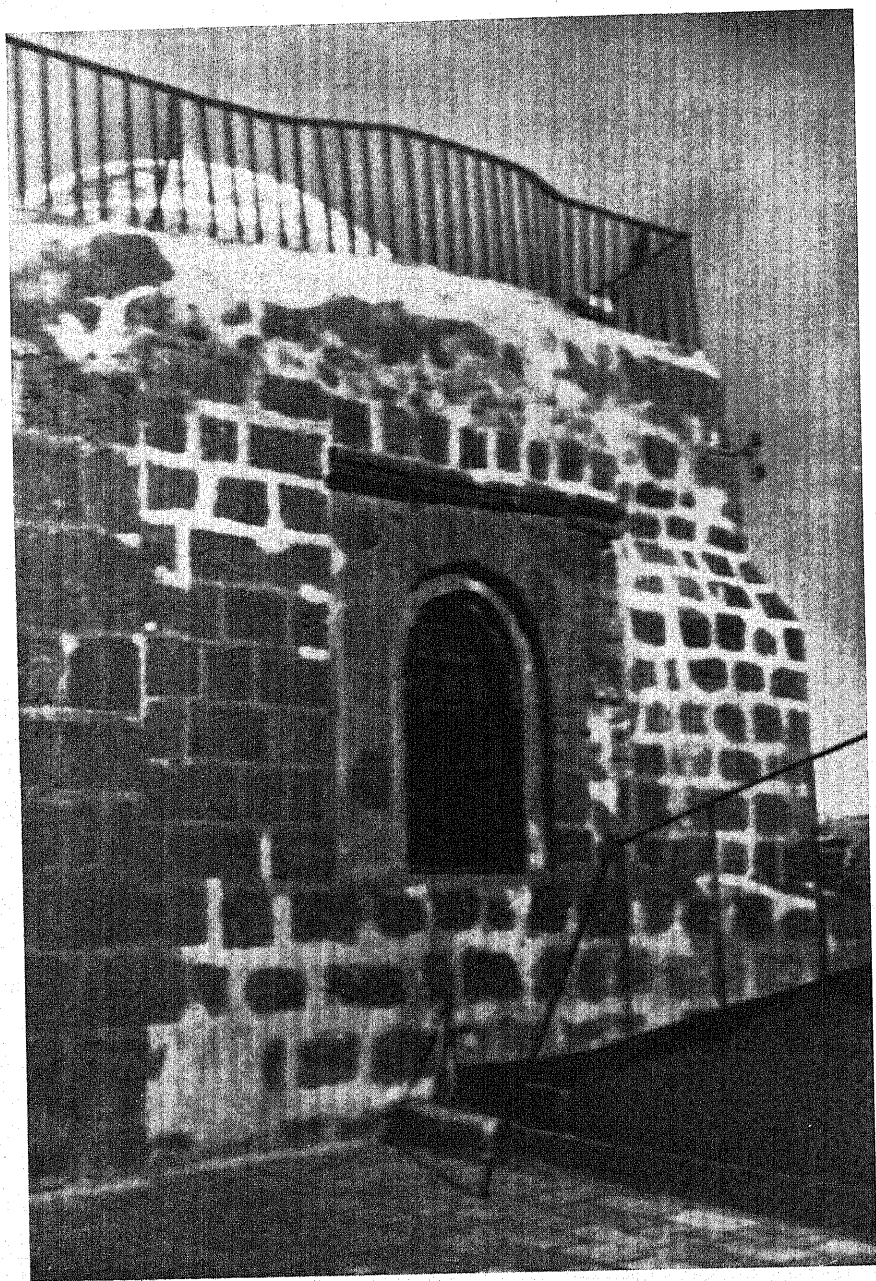
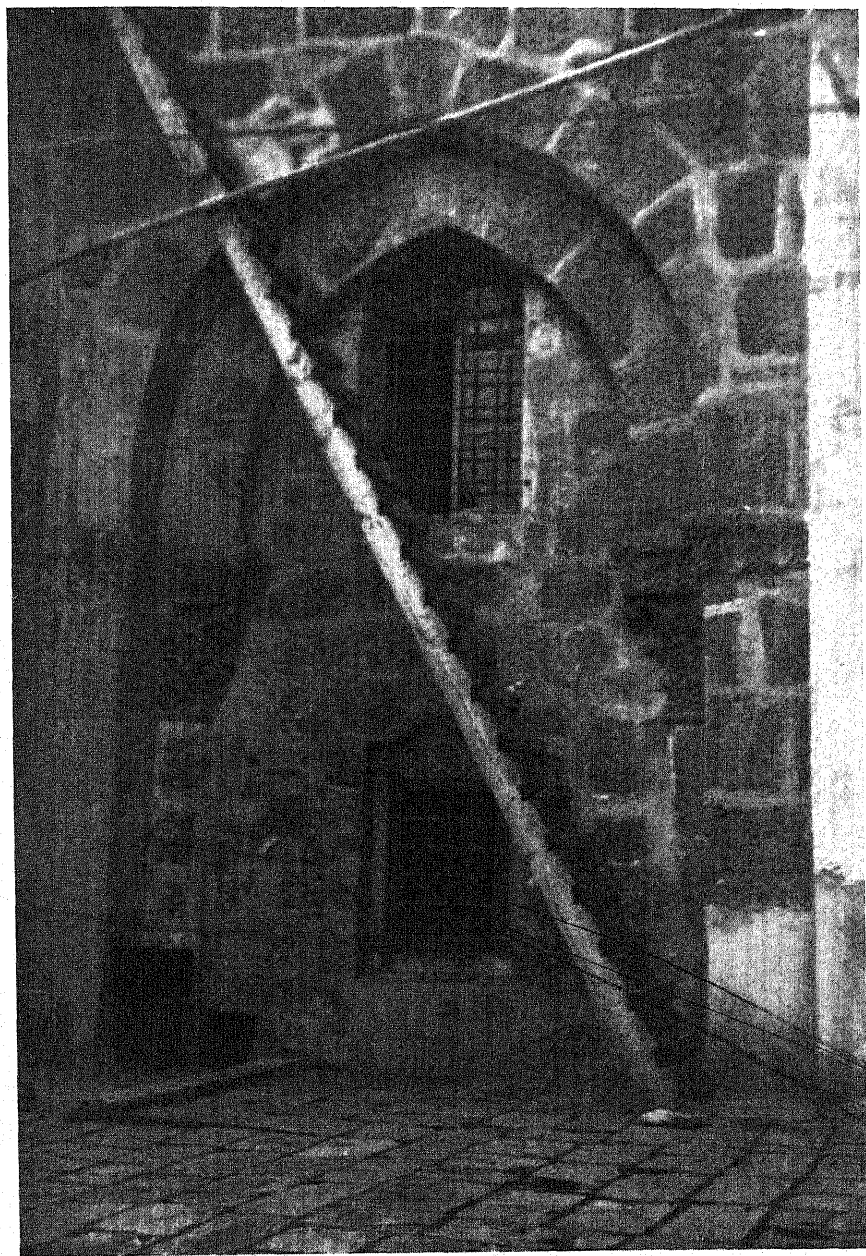
(18) Removal of modern accretion from beneath Byzantine octagonal cupola to east of Chapel of Melchizedek, and opening of old window in its South-east wall (see Figs. 103, 104, II, 12).

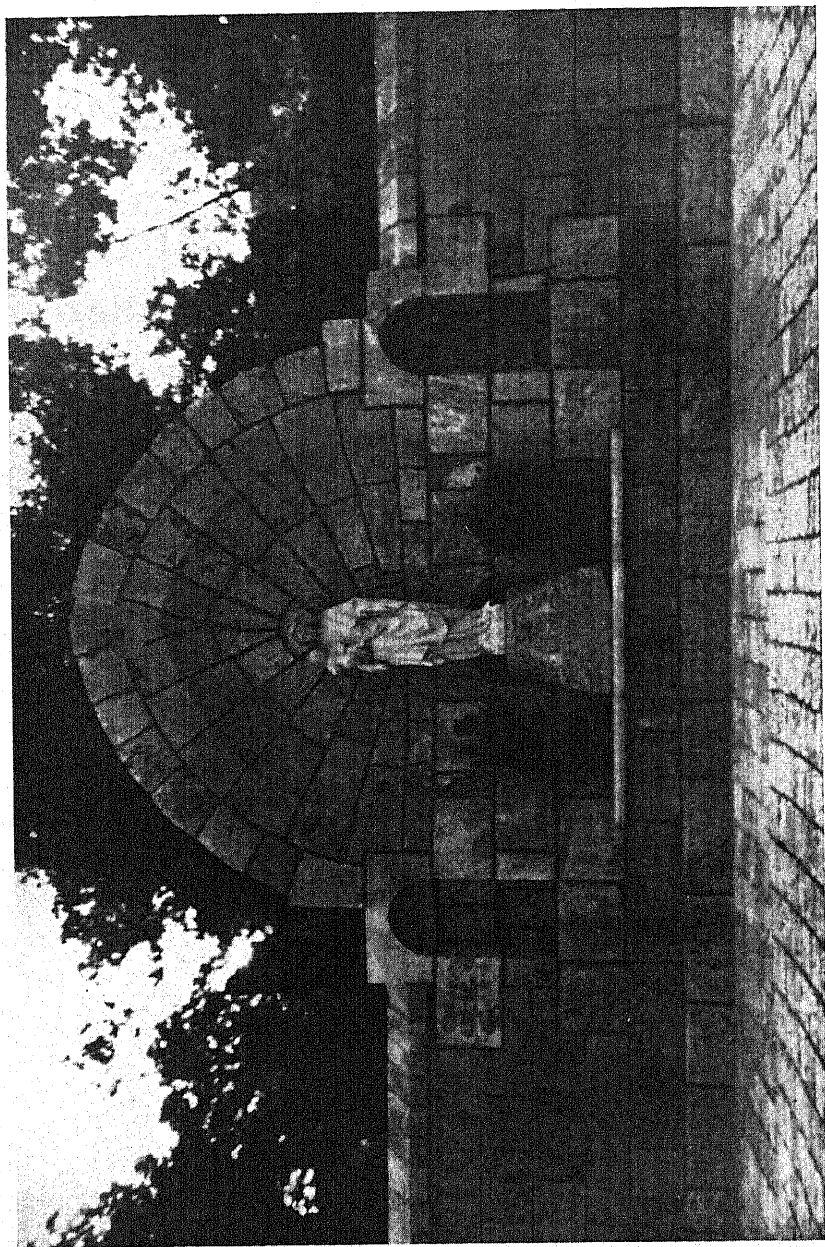
FIG. 105. OLD DOOR TO UPPER AMBULATORY

(19) Removal of modern floors and partitions inside old arch of upper ambulatory, leading to the Greek Terrace, and reopening of arch as a doorway (see Fig. 105).

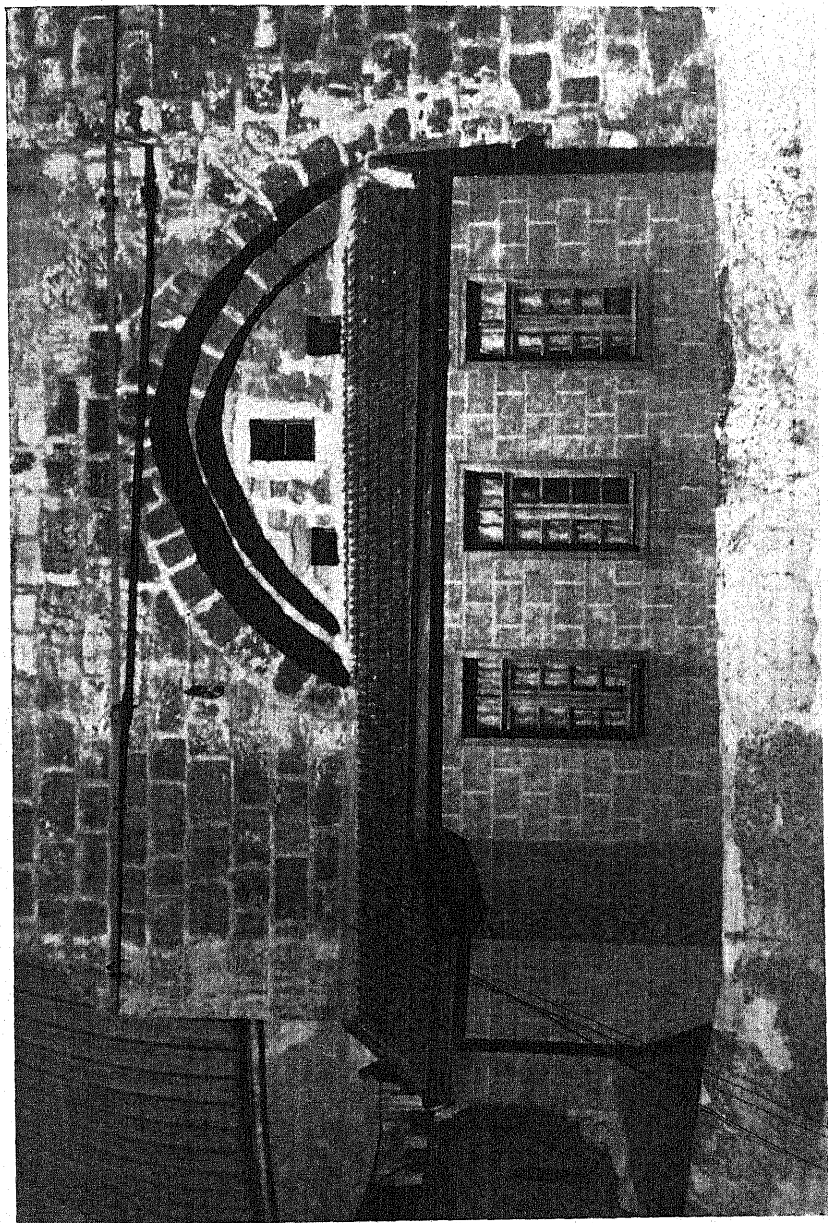
FIG. 106. NICHE FROM ROOF BY ROTUNDA, NOW AT ST. ANNE'S

in 1870 and its restoration to its original position on the roof of the Rotunda gallery, as a window opening through the upper blind arcade of the Rotunda drum (see Fig. 106).

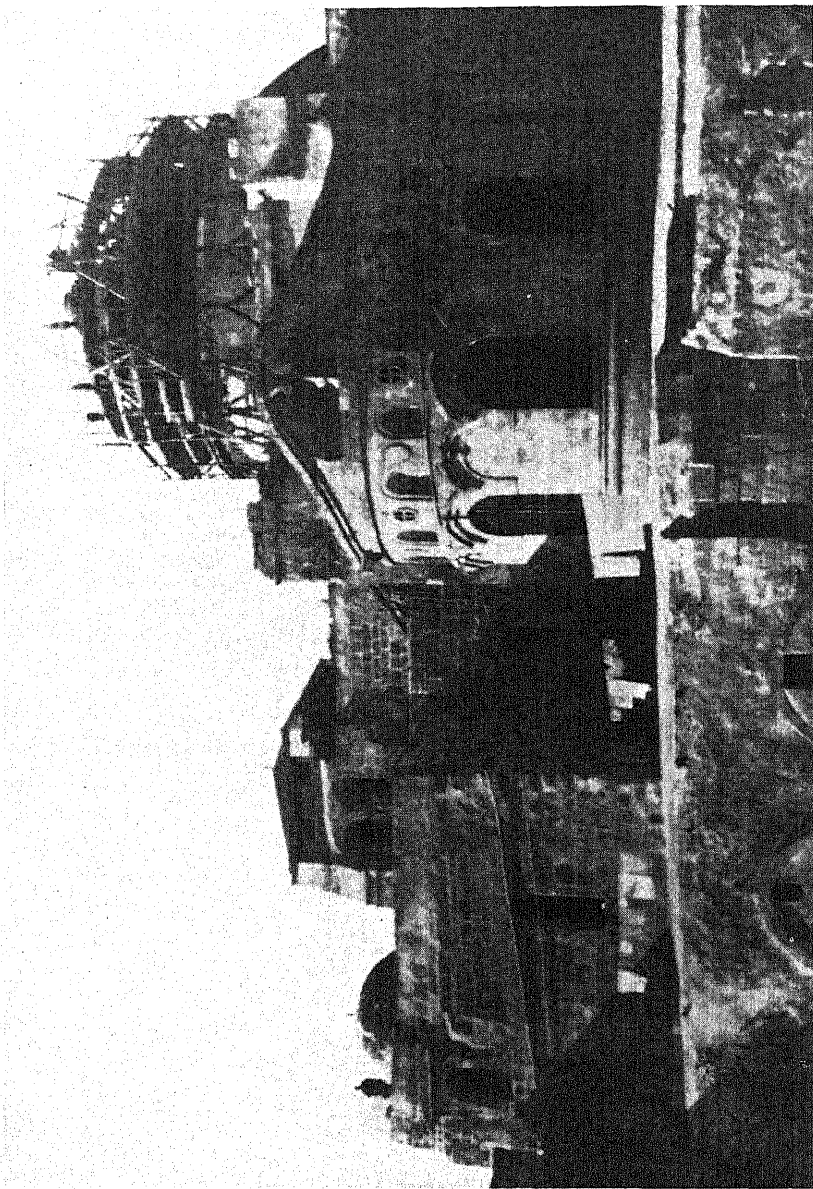
FIG. 107. MODERN ROOM ATTACHED TO TOWER

(21) Removal from the South face of the Tower of the modern room added to the floor above the vault of the Chapel of the Forty Martyrs (see Fig. 107).

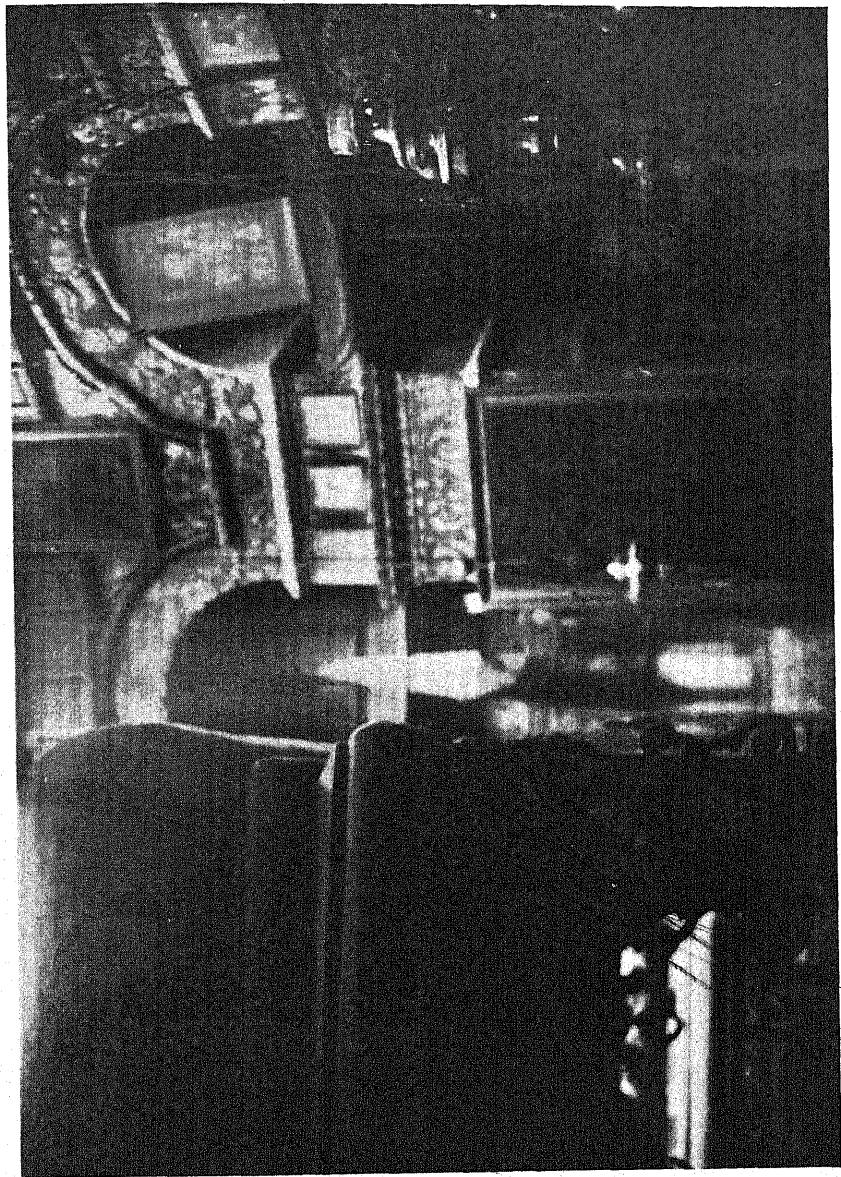
FIG. 108. EAST END

(1) During the reconstruction of the apse, made necessary by its decay, it should be redesigned as far as possible according to its original form, and, in any case, to harmonize with the general design of the building (see Figs. 108, 110, I, 6).

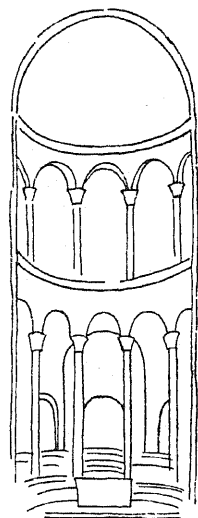
FIG. 109. PIERS OF APSE, AS BUILT IN 1810

(2) It will probably be found that the original twin columns of the lower apse arcade exist inside the present square piers. If so, they should be revealed, and reconstructed if necessary to bear the load. In any case, twin columns following the original design should be substituted for the massive piers (see Figs. 109, 110).

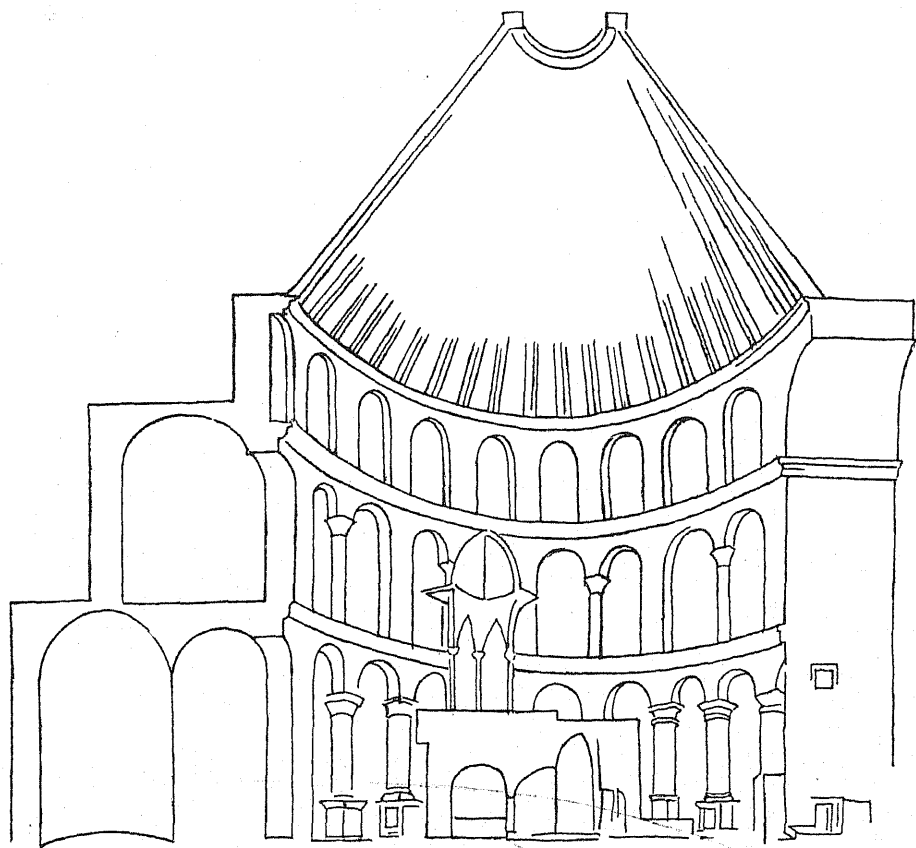
FIG. 113. AMICO'S SIXTEENTH-CENTURY DRAWING  
OF THE ROTUNDA

(4) Should remains be found during the work of repair in the Rotunda piers, of the original columns, they should be reconstructed, and the arcade and galleries returned as nearly as possible to their original Byzantine form (see Fig. 113).

(4) The removal of the present dome over the Rotunda and its replacement by a cone following the original design, which was adhered to in many rebuildings up to the fire of 1808 (see Figs. 113, 118).

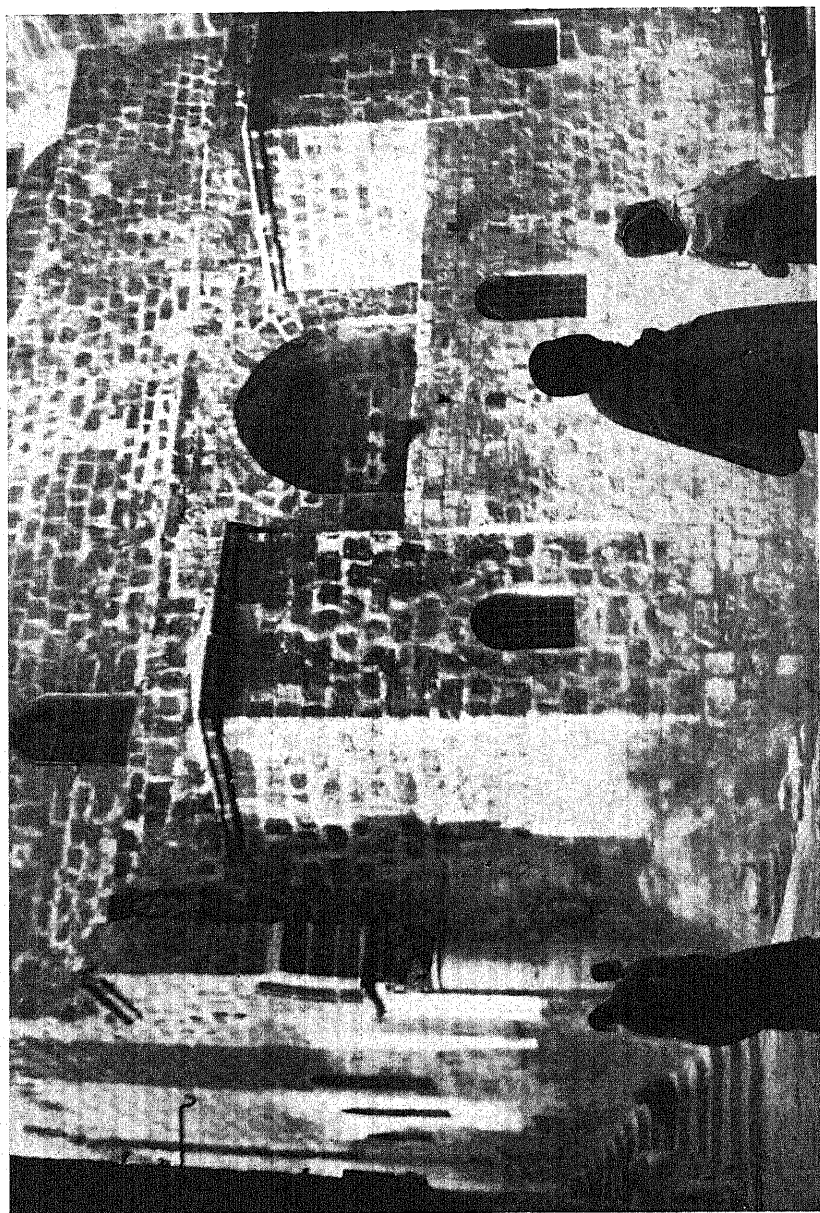
FIG. 114. WEST SIDE OF PARVIS

Parvis, from the present remains: the western half pier and portion of one arch, with above it a fragment of the original crowning mouldings of the arcade, and the bases still *in situ* (see Figs. 114, I, 41).

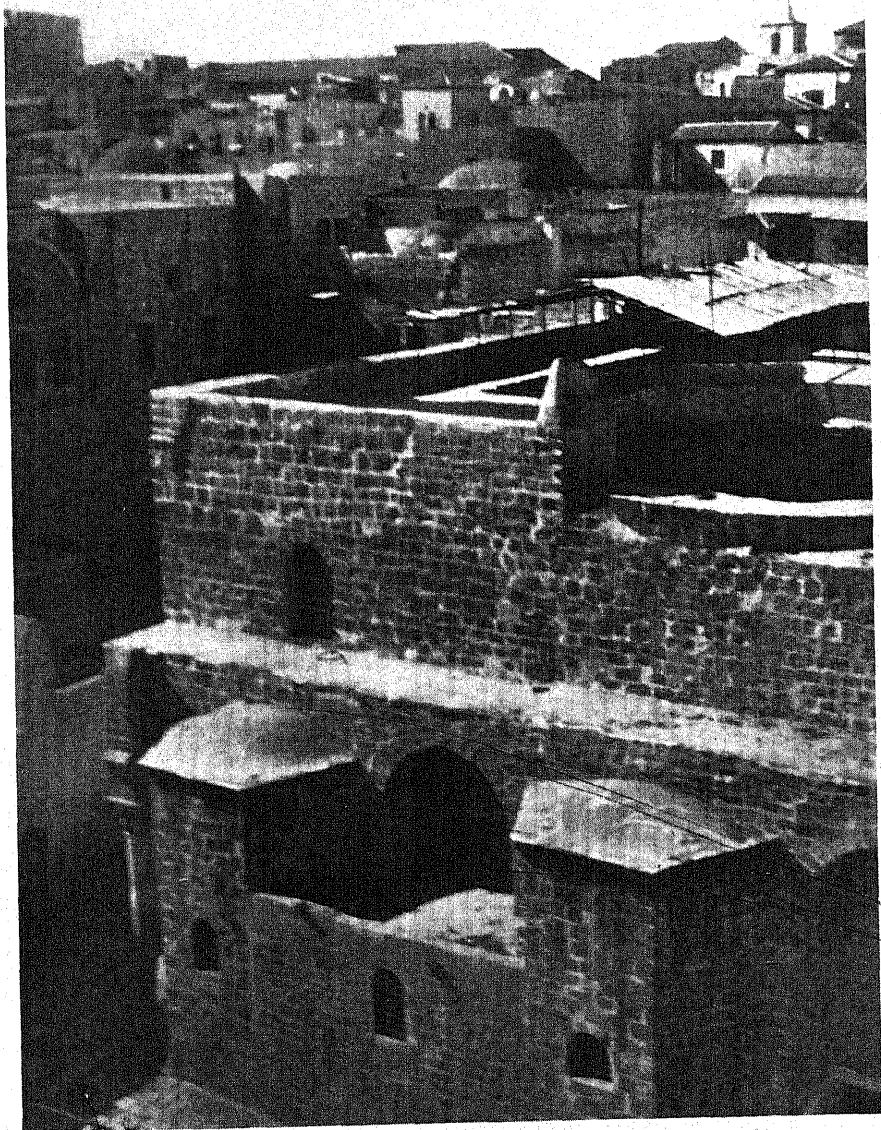
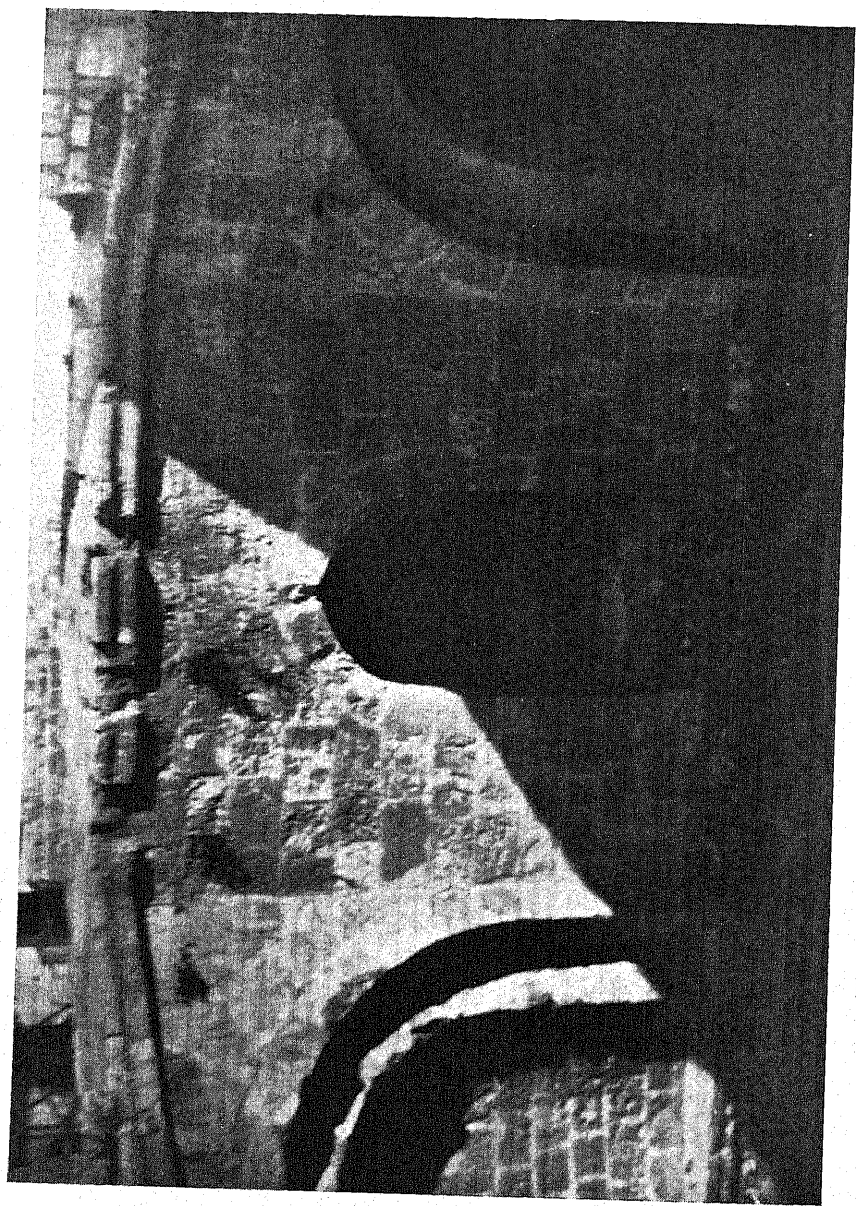
(2) The rebuilding of the dome over the old Baptistery south of the Tower, and the subsequent removal of the lower vault which partially covers the space at present; also the opening of the blocked window in the eastern face (see Figs. 115, 116, I, 32-II, 19).

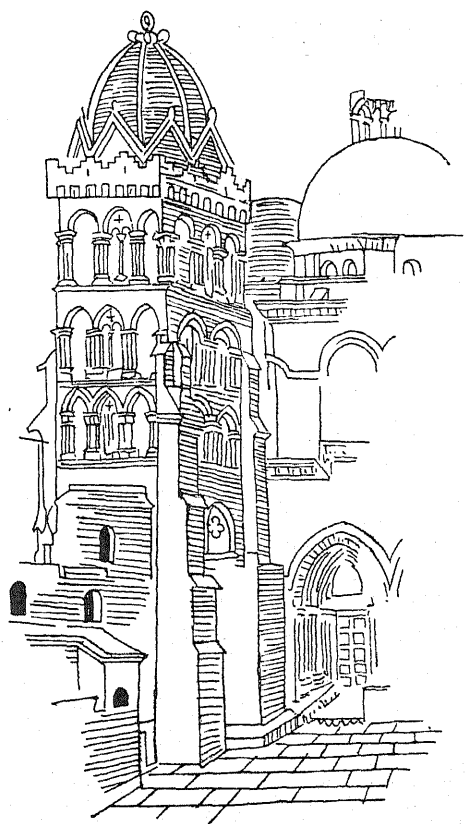
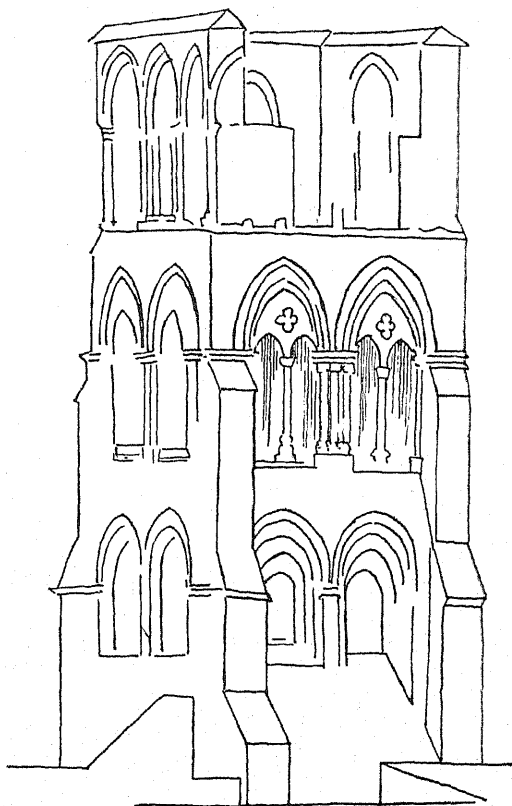
FIG. 117. OLD VIEWS OF THE TOWER

(3) The rebuilding of the upper stories and roof of the Tower. This would be in accordance with the bases of an upper arcade still *in situ*, by comparison with the marble columns now re-used in the Chapel of Constantine on the roof nearby, and with many old engravings and drawings, taken while the Tower remained entire (see Fig. 117).
